First Five-Year Review Report for the Bailey Waste Disposal Site Orange County, Texas

September 2000

**Bailey Waste Disposal Site
EPA ID# TXD980864649
Orange County, Texas**

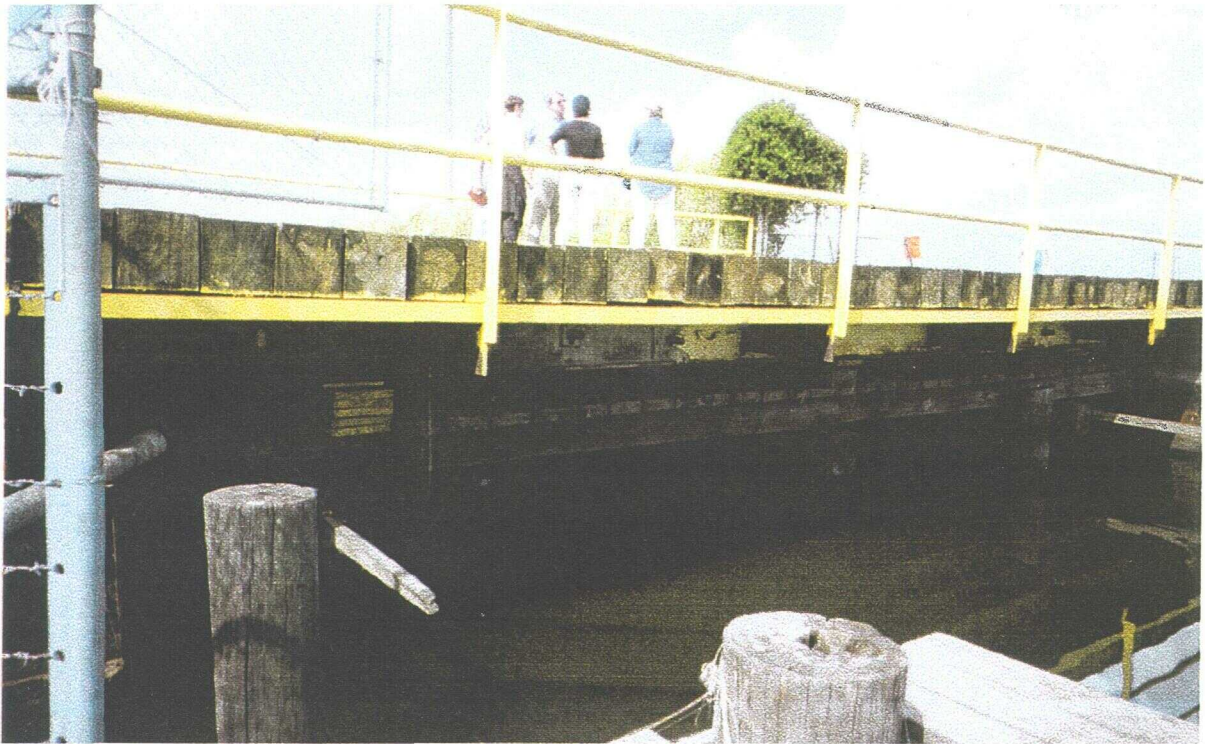
Photo No. 1 of 23	Date: 7/10/00	Time: 10:15	Taken by: Mark Taylor
View looking west at the BWDS site access bridge from the adjacent pier located north of bridge. The bridge was rebuilt in March 2000 according to Mr. C. Orwig.

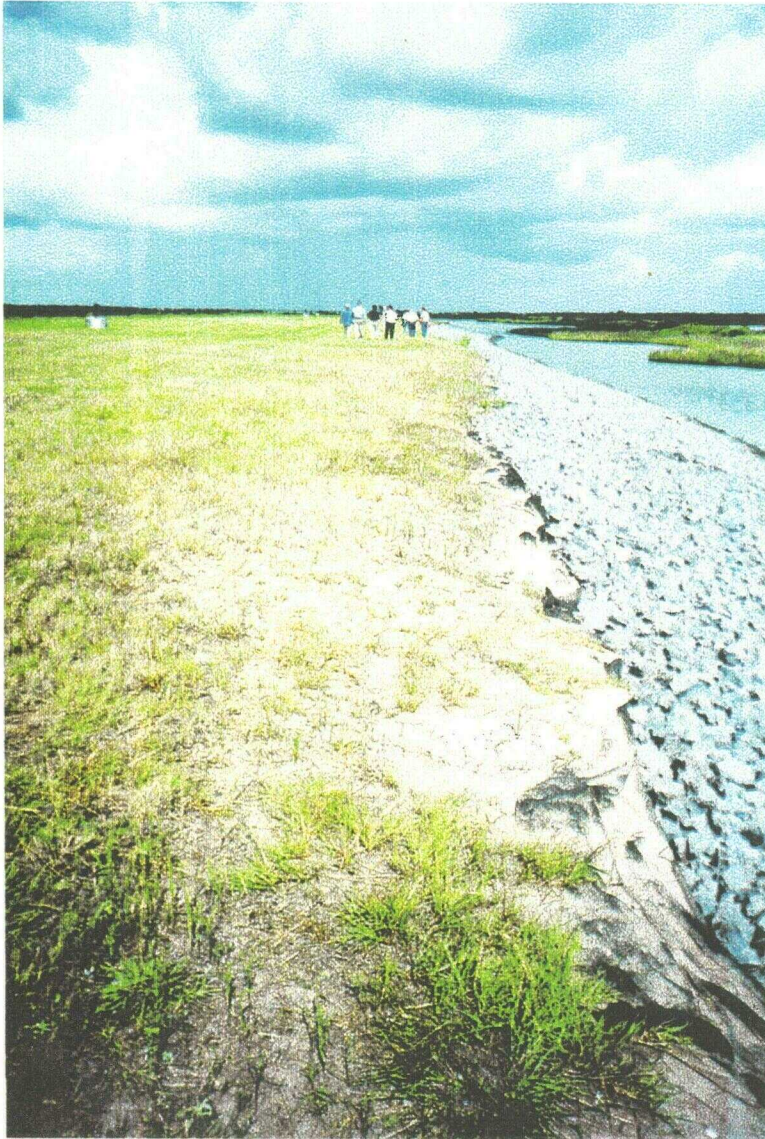
Photo No.	3 of 23	Date:	7/10/00	Time:	10:25	Taken by:	M. Taylor
View of north side of the North Dike Area looking west at the sparse, distressed vegetation and liner.

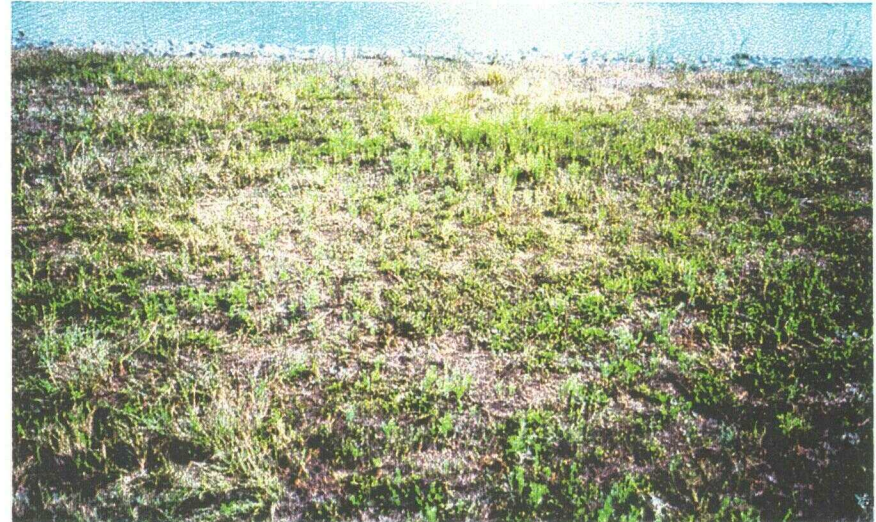
Photo No.	4 of 23	Date:	7/10/00	Time:	10:25	Taken by:	Mark Taylor
View of the north side of the North Dike Area looking north at mixed, sparse, distressed vegetation.

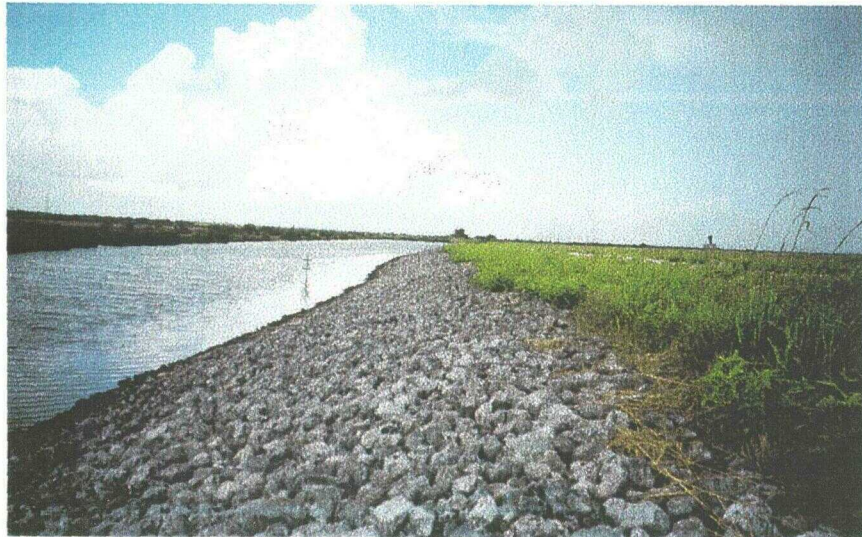
The landfill caps were found to be in good condition. Overall, the vegetative cover was thorough, though sparse and distressed in several areas. No trees or shrubs were observed to be growing on either the East or North Dike Area caps. The depression in the rip-rap noted in earlier inspections had been regraded, and to date remains comparatively contoured with the adjacent material. A new area of differential settlement seems to have formed in the protective rip-rap on the north side of the North Dike Area between the second and third vents as counted from the east.

Photo No. 8 of 23	Date: 7/10/00	Time: 10:55	Taken by: Mark Taylor
View of midway down the North Dike Area on the south bank looking west at the differential settlement repair area.

Differential settlement observed on the North Dike Area and other site maintenance issues identified during the five-year review will need to be closely monitored and corrected, as needed. To achieve long-term effectiveness of the remedy, it will be necessary to maintain the integrity and effectiveness of the final cover, including making repairs to the cap as necessary to correct the effects of settling, subsidence, erosion, or other events. The long-term effectiveness of the remedy will also be contingent upon the implementation of all necessary institutional controls.

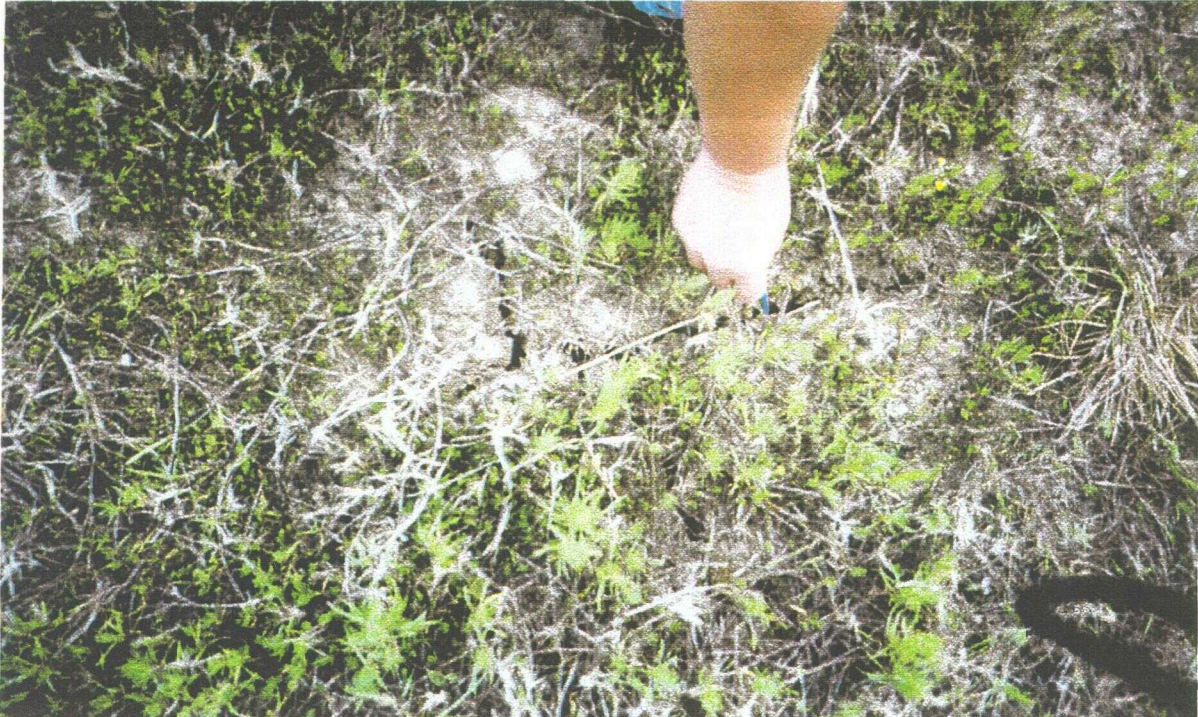
Small desiccation cracking was observed throughout both the East and North Dike Area caps but not to the extent of revealing the underlying geocomposite drainage layer. No excessive cracks, leachate seeps, odors, or other indications of distress were noted.

Photo No. 9 of 23	Date: 7/10/00	Time: 11:00	Taken by: Mark Taylor
Typical view of typical dissipation cracking encountered during the 7/10/2000 inspection.

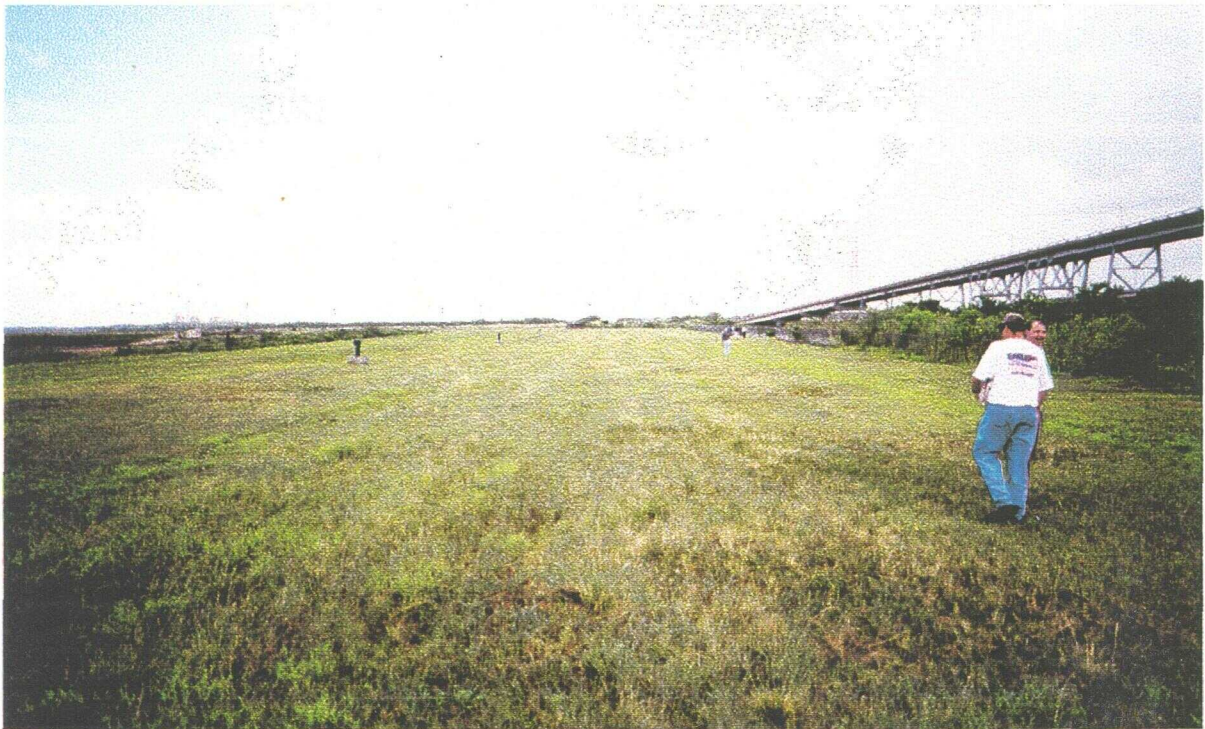
Grounds maintenance is outlined in Section 3.1 of the Final Inspection, Maintenance, and Monitoring Plan. Section 3.1 states, "The area to be mowed includes the area between the fence and the toe of the rip-rap along the southern end of the East Dike." The five-year review site inspection observed vegetation below the rip-rap in the southern end of the East Dike Area, which indicated that this area has not received sufficient mowing. Vegetation within the rip-rap was not observed; however, within the 10-foot shoulder between the bottom edge of the rip-rap and the bordering fence exist several young trees. Although the security fencing appeared in good condition all along the entire east and south sides of the East Dike Area and appeared to be well posted with warning signs, small trees had begun to penetrate the

Photo No. 10 of 23	Date: 7/10/00	Time: 10:15	Taken by: Mark Taylor
View of the south end of the East Dike Area looking north at vegetative cover. The fence was obscured by growth.

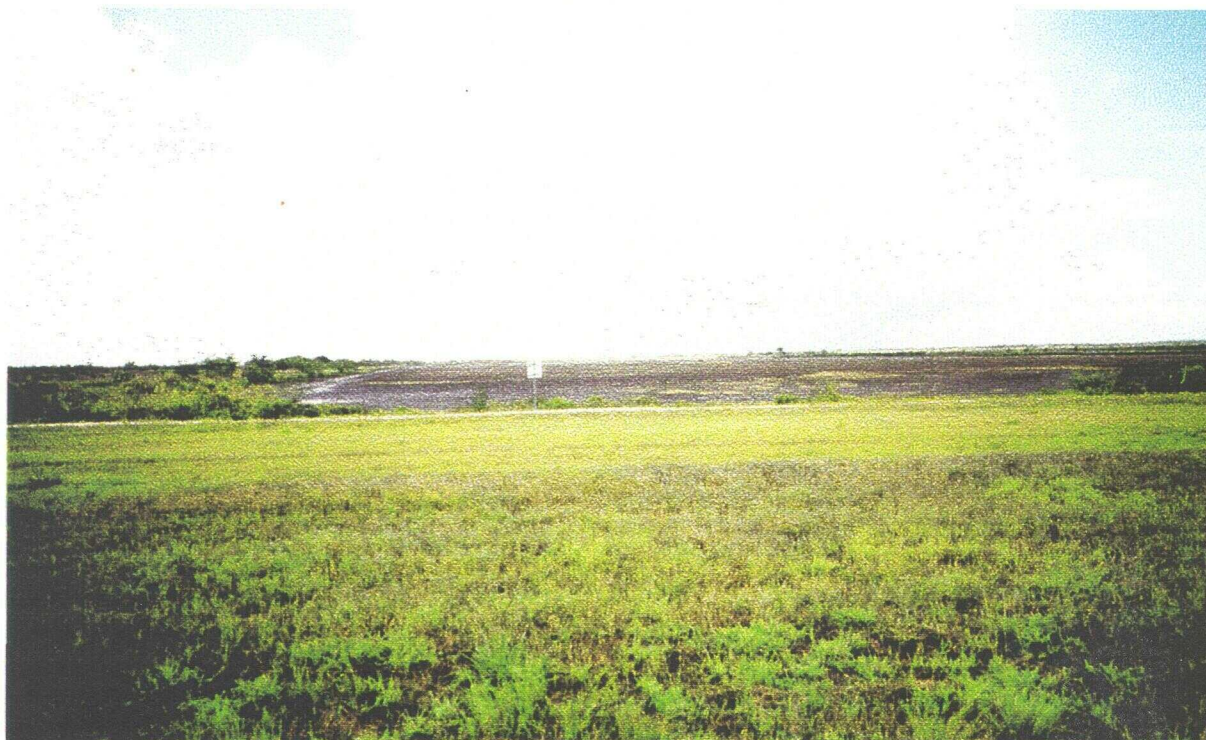
Photo No. 12 of 23	Date: 7/10/00	Time: 11:30	Taken by: Mark Taylor
View of the East Dike Area looking west at the dry pond.

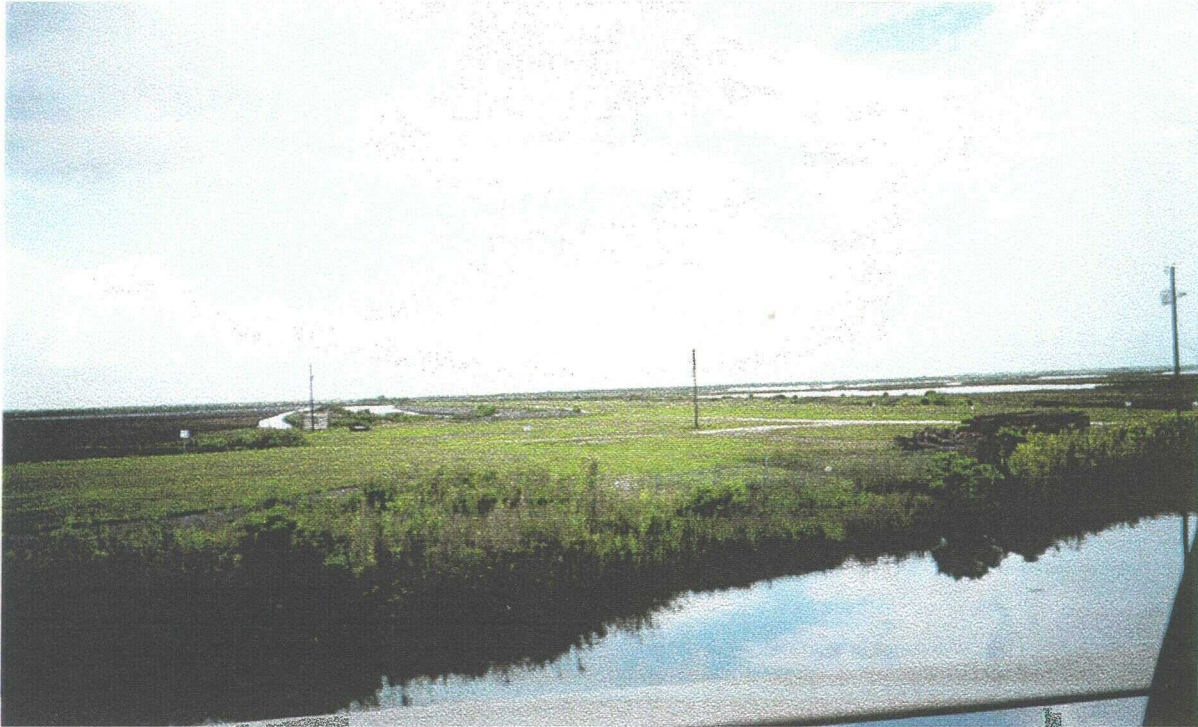
Prompted by the land owner, an inspection of the laydown and staging area identified a "debris pile" of discarded lumber consisting of the matting material once used as foundations for the heavy equipment that worked on the cap, planking and subframing material removed from the access bridge in March 2000, and other unidentified debris and discarded material. Also the foundation and containment structures associated with the construction of the on-site water treatment plant still remain.

Photo No. 13 of 23	Date: 7/10/00	Time: 12:00	Taken by: Mark Taylor
View from the road looking west at the staging area. Note the debris pile on the left, WWTP, and surplus rip rap material in the center, and posted warning signs throughout.

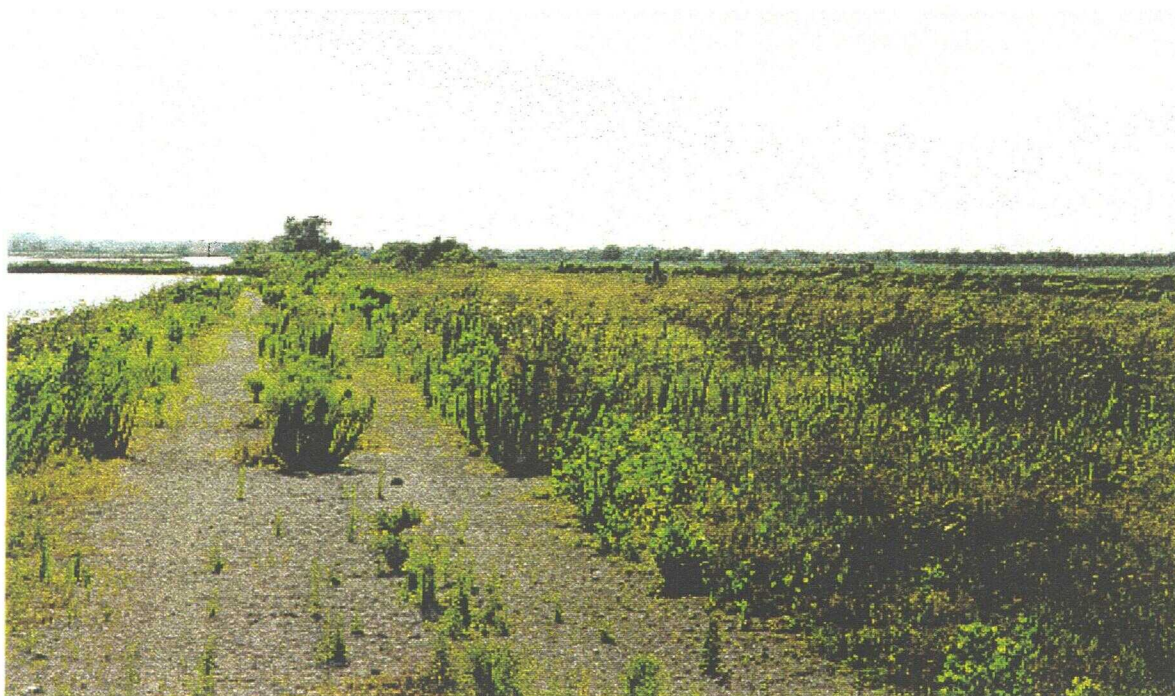
Photo No. 20 of 23	Date: Unknown	Time: Unknown	Taken by: Unknown
Photograph of growth in the access road provided by Mr. Townsend.

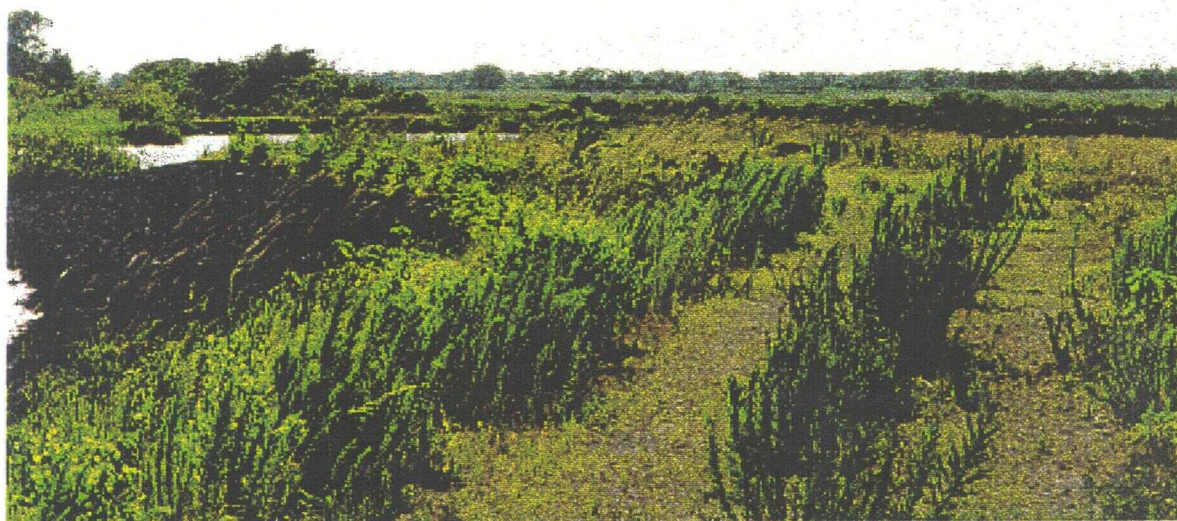
Photo No. 21 of 23	Date: Unknown	Time: Unknown	Taken by: Unknown
View of unmaintained vegetative growth at Baily Waste Disposal Superfund Site provided by Mr. Townsend.

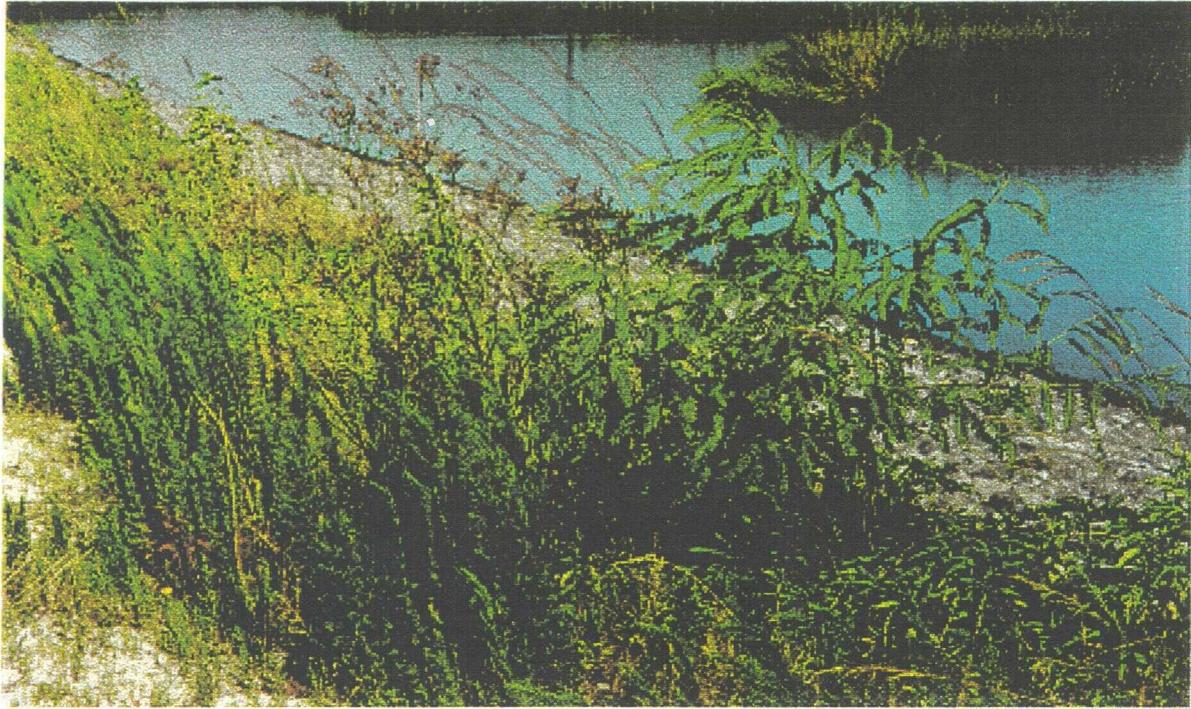
Photo No. 22 of 23	Date: Unknown	Time: Unknown	Taken by: Unknown
View of unmaintained vegetation provided by Mr. Townsend.

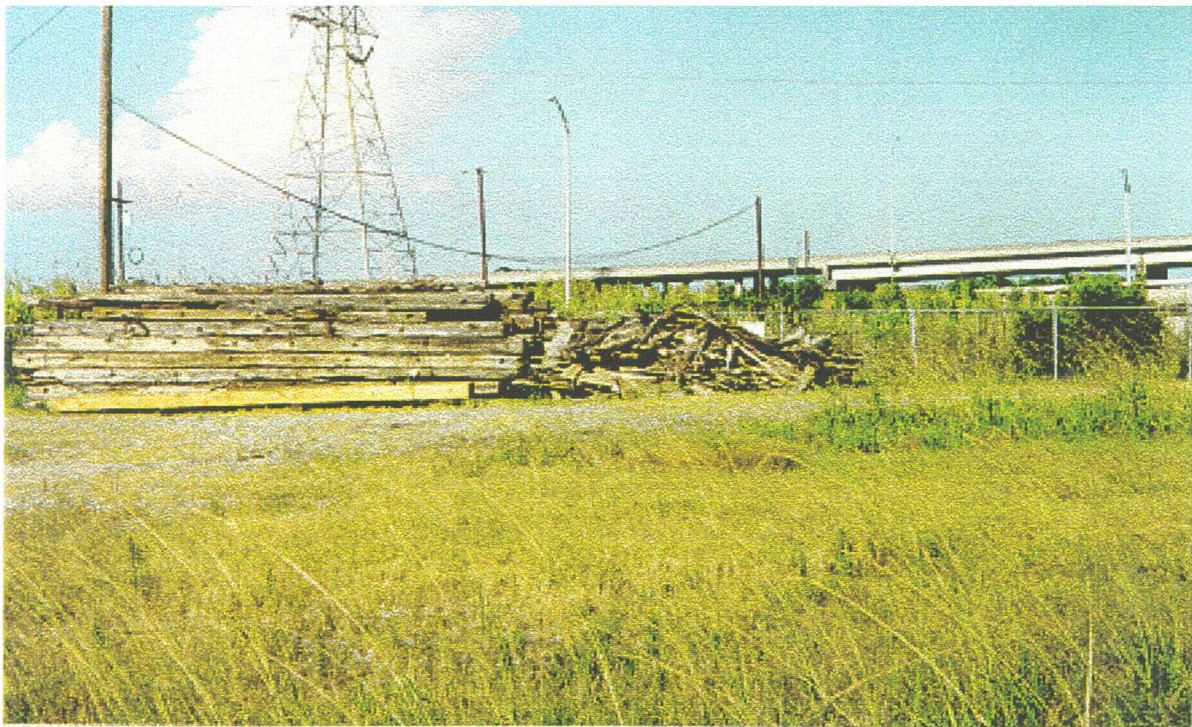
Photo No. 23 of 23	Date: Unknown	Time: Unknown	Taken by: Unknown
View of debris pile provided by Mr. Townsend.
